FINDING OF NO SIGNIFICANT IMPACT/RECORD OF DECISION

LAND EASEMENT AND CONSTRUCTION OF RUNWAY 18/36

MEDICINE LODGE MUNICIPAL AIRPORT MEDICINE LODGE, KANSAS

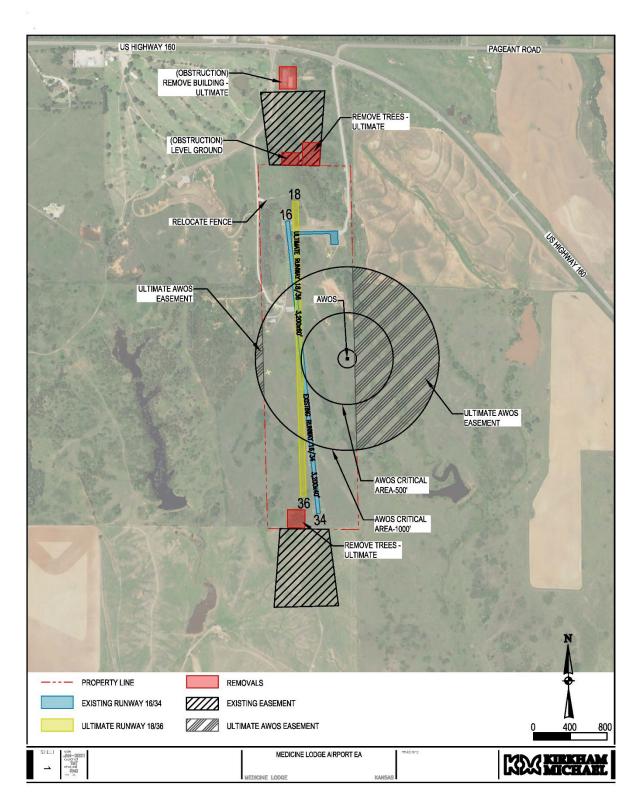
Figure 2. Proposed Improvements

Figure 1 shows the project location map, and Figure 2 shows the proposed improvements. Figures 3 through 6 are photographs of the Airport.

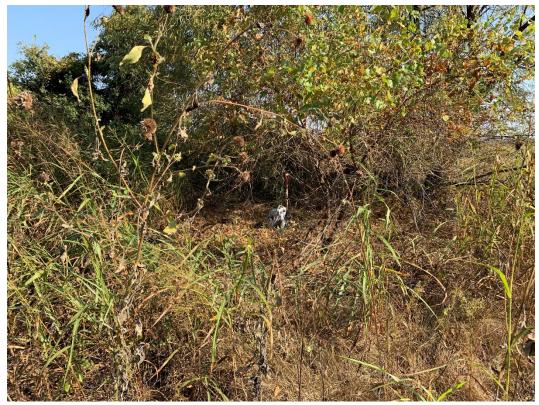
Figure 3. PFOA wetland onsite

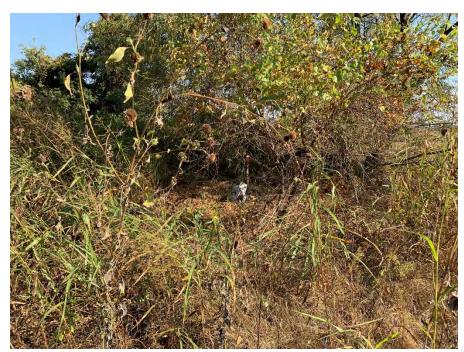
Photo 1. View southeast of PFOA area.

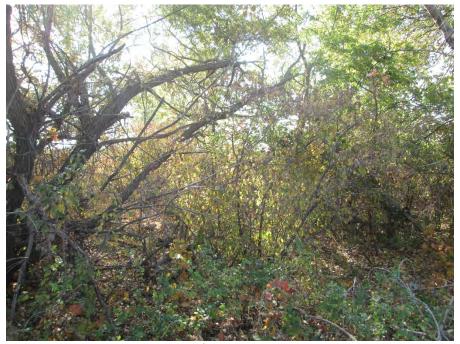
Photo 7. View southeast of PFOA wetland in depressional area.
